Tree Evaluation During Property Development

THE INSPECTION OF THE TREES AT THE PROPOSED DEVELOPMENT SITE
FOR A HOSPITAL FACILITY AND SHOPPING CENTER AT SILVER CREEK VALLEY PLACE - SAN JOSE
Prepared By: Nigel Belton - ISA Certified Arborist WE410A on behalf of Barrie D. Coate and Associates
Site visit - November 19, 2013

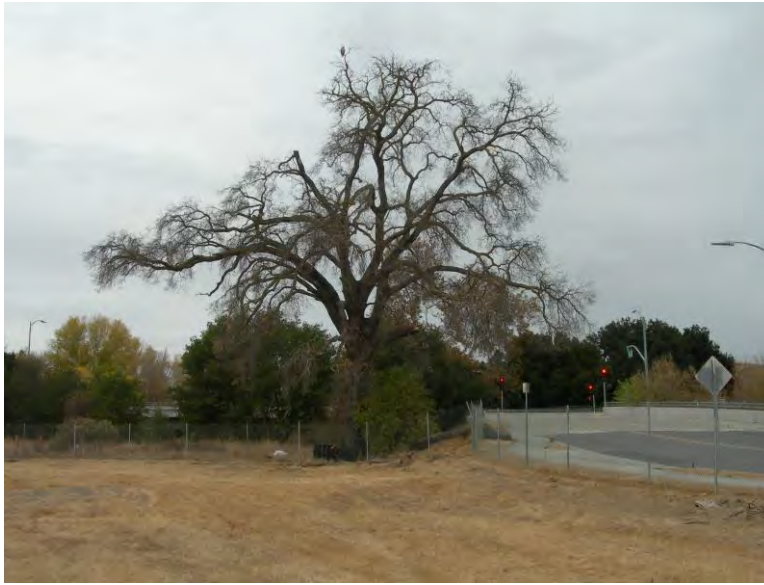
This large dead tree is located on the adjacent property at the north end of the development in close proximity to Silver Creek Valley place. The tree canopy extends out well over the development property (approximately 40 feet) and also over the sidewalk and roadway of the adjacent street. This tree must be removed promptly as it is a significant hazard to the street and constitutes a potential hazard to the development site. I noted that it is in a state of advanced decay and that it has already dropped several large limbs on the street.

Tree #1 – Dead 48 inch Coast Live Oak to be removed - Looking north:

- Note the proximity of the street and development site

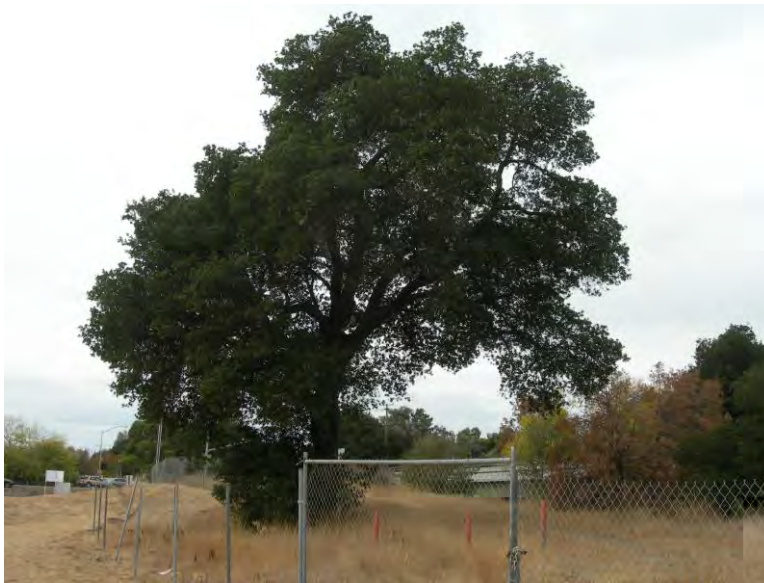
This large Coast Live Oak is located within 10 feet of the boundary on the adjacent property to the north. The tree has developed a heavy scaffold limb structure on the north side of its canopy. It is a significant old oak worthy of preservation and will contribute aesthetic value to the proposed development. I recommend that this tree is pruned to improve its structure by reducing weight on heavy and overextended limbs. The removal of the profuse sucker growth in the area of the lower trunk will enhance its appearance.

Tree #2 – The large Coast Live Oak to be preserved – Looking west:

- Note the heavier canopy development on the north side of the tree

I recommend that TPZ fencing is erected 10 feet beyond the south side of the canopy drip line to ensure that more of the critical roots are protected during construction (I noted the close proximity of the trunk to the boundary line and that the spread of the south facing canopy is relatively narrow compared the width of the balance of the canopy that extends over the neighboring property).

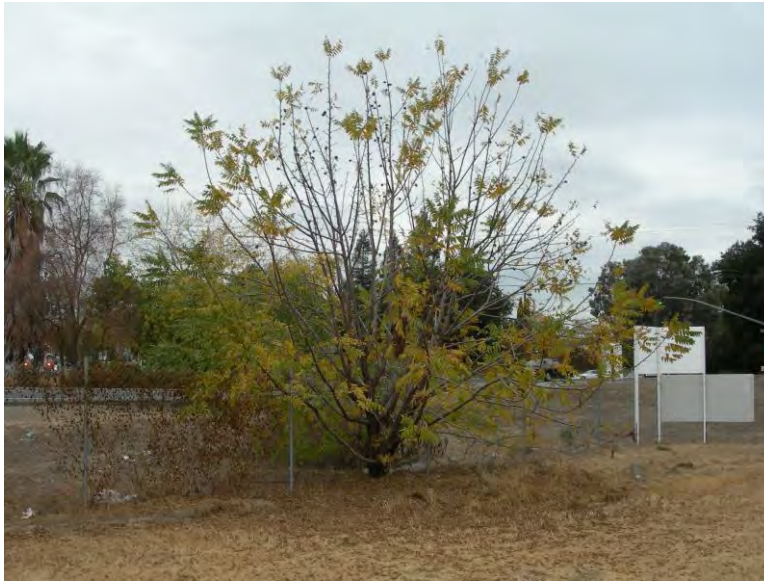
It should be removed due to its poor structure which consists of multiple stems emanating from a common stump. This structure will become problematic regarding its structural integrity, as it grows larger over time because these stems may become predisposed to failing at their attachments to the original stump. The tree has poor aesthetic merit and replacement with more appropriate species is recommended.

Tree #3 – 6 & 4 inch Black Walnut stump sprout to be removed:

- Note the crowded growth pattern of the regenerating sprouts

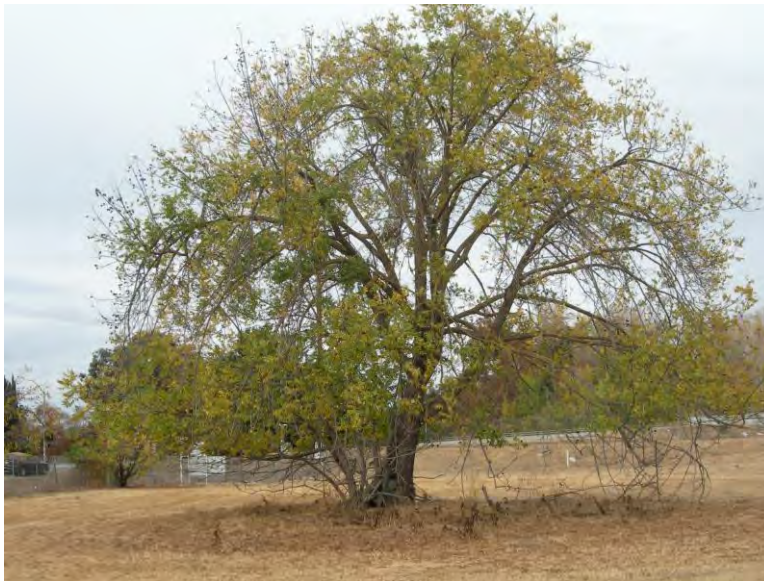
This tree is the only Black Walnut on this site that may be preserved as it has a single trunk structure however it is not a particularly good specimen when considering its condition. The tree has a fair to poor structure rating and will require pruning and significant tree protection measures to ensure its long-term survival. Note that Walnuts are very sensitive to root disturbance and root loss.

Tree #4 – 23 inch Black Walnut – An option to be preserved:

- Note the fair to poor structure of this tree

Replacement with a large Coast Live Oak is also worthwhile consideration, particularly if this tree is surrounded by an extensive area of paving which may not favor the health and survival of this walnut tree over the longer term.

I recommend that the tree is irrigated to mitigate the loss of roots beyond the canopy drip line (at a rate of 230 gallons every three weeks over the summer period for a minimum period of three years).

The soil surface under the canopy must be mulched with a three-inch deep layer of wood chips to preserve soil moisture.

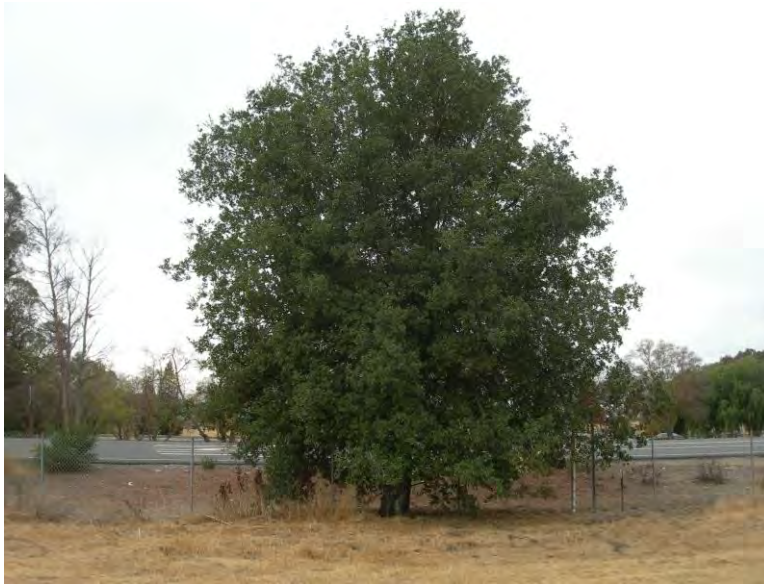
Tree #5 – 21 inch Coast Live Oak - Looking west – Suitable for preservation:

- Note that low tree canopies should be raised to allow more visual access from the road

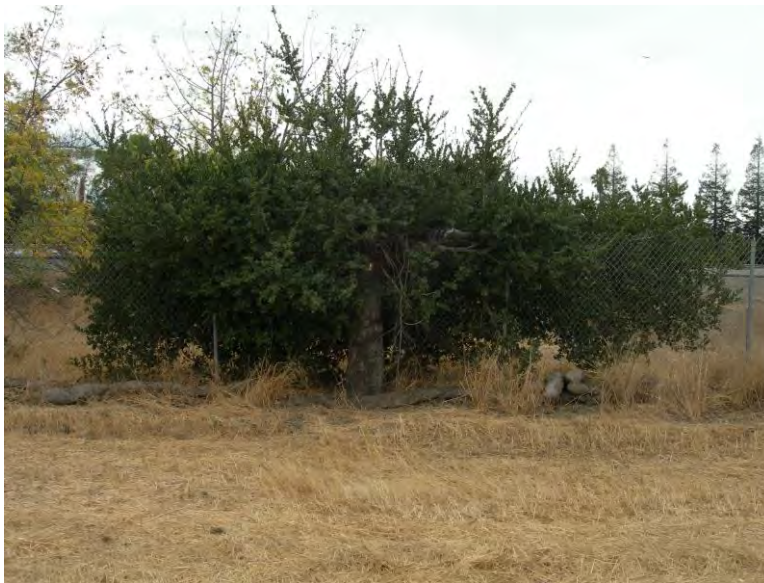
The trunk of this tree has broken off at five feet above grade.

Tree #6 – 13 inch Coast Live Oak – Recommended for removal:

- Note the broken top of this tree

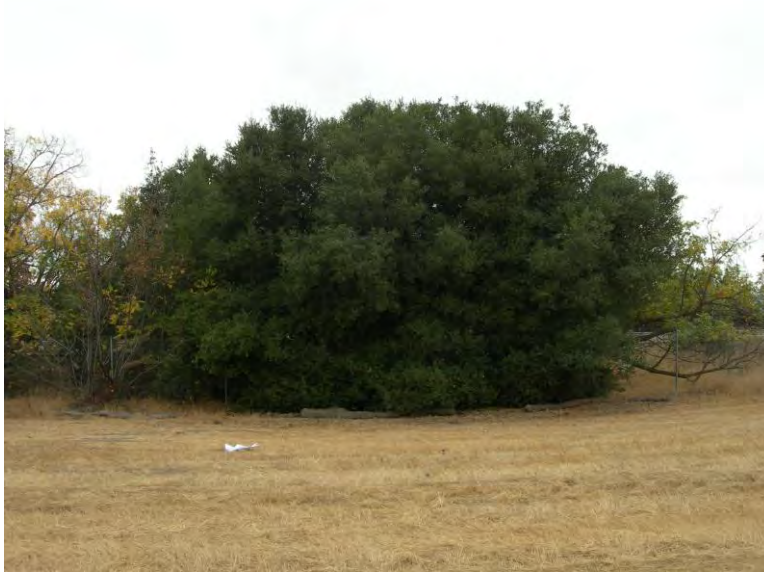
Tree #7 – 10, 13 & 11 inch Coast Live Oak – Suitable for preservation:

- Note that this tree should be pruned to reduce weight and raise the canopy

This tree requires pruning to remove dead and crossing branches and to reduce end weight on heavy limbs and branches. The low canopy should be raised to about eight feet above grade. The installation of three cable sets higher in the canopy is recommended as a means to reduce the possibility of failures in the areas of attachment between the trunks.

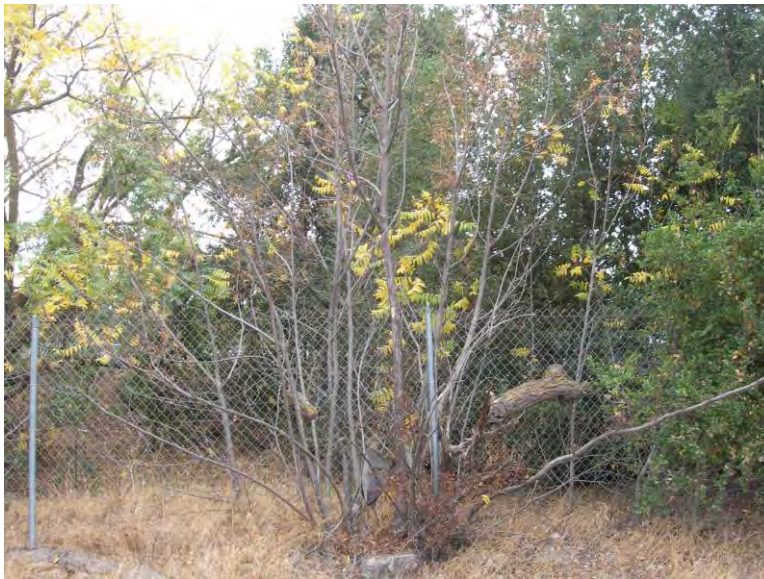
Tree #9 – 3, 2, 2 Black Walnut stump sprout:

- Representative of numerous stump sprouts in the proximity of the fence that require removal

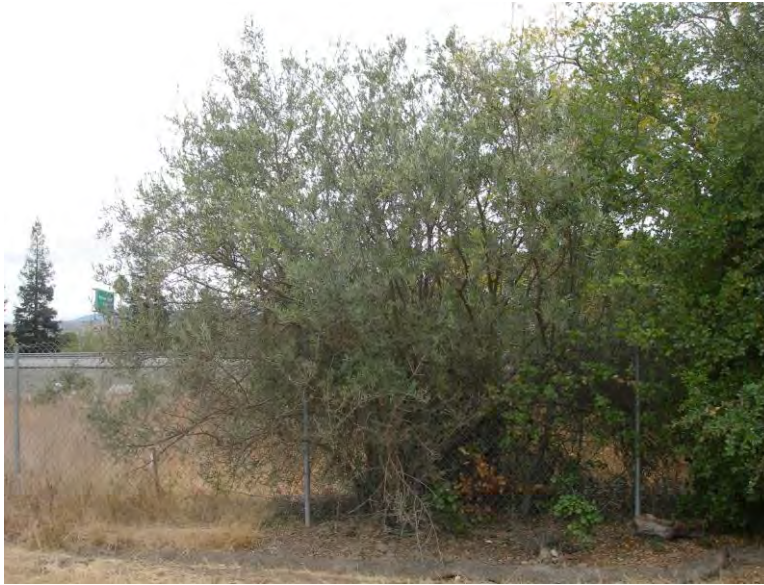
Tree #11 – 4, 4 & 3 inch European Olive recommended for removal:

- Growing on the fence line

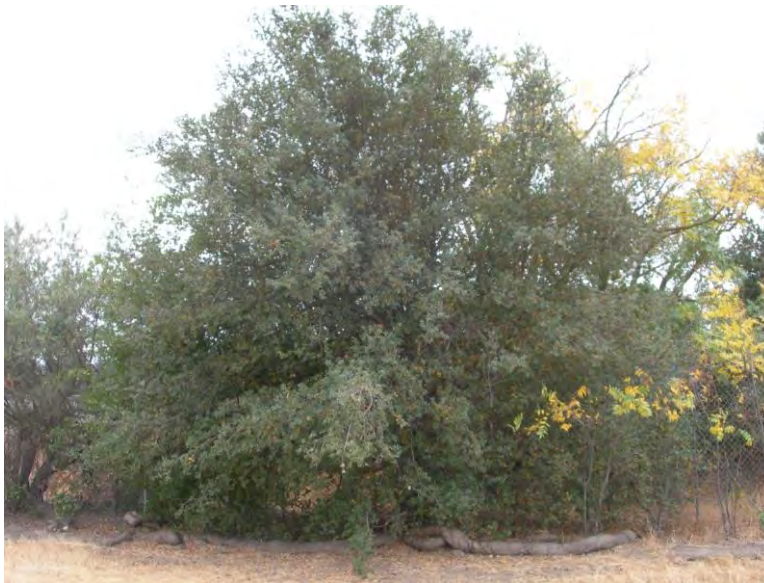
Tree #10 – 6, 4 & 4 inch Coast Live Oak – Recommended for removal:

- Poor structure and close proximity to fence line

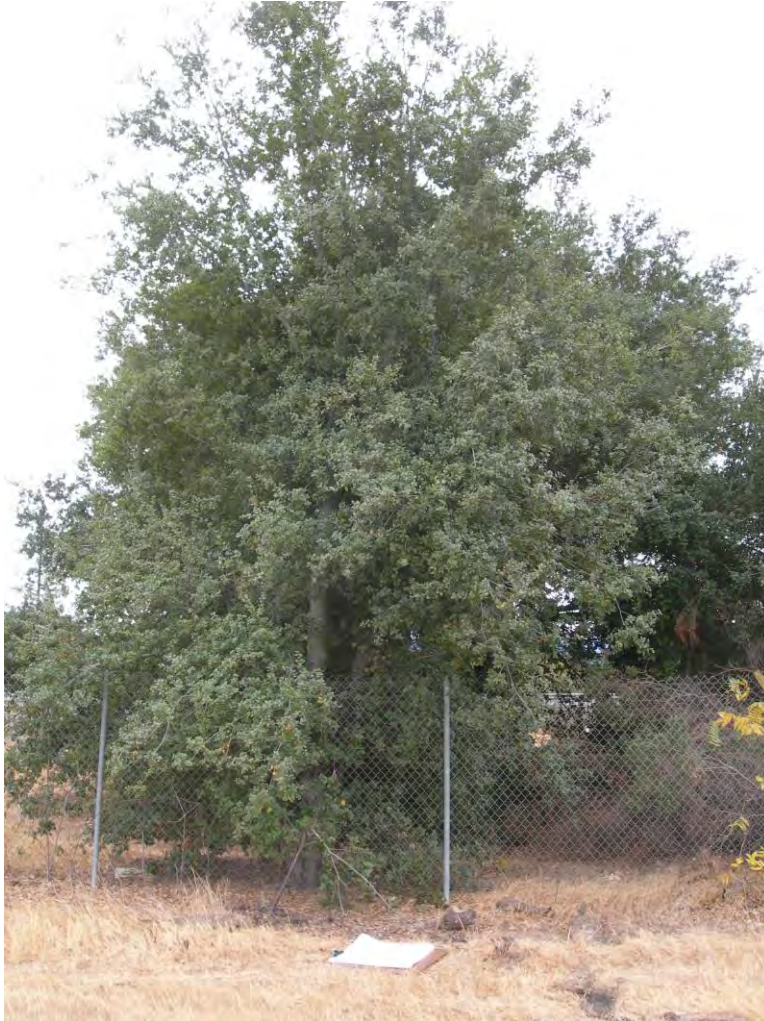
Tree #14 – 8 & 5 inch Coast Live Oak recommended for removal:

- Located on the Caltrans side of the fence (within the boundary stake line as discussed in the report)
 - This tree is crowded and is blocking visual access to the site from the exit road

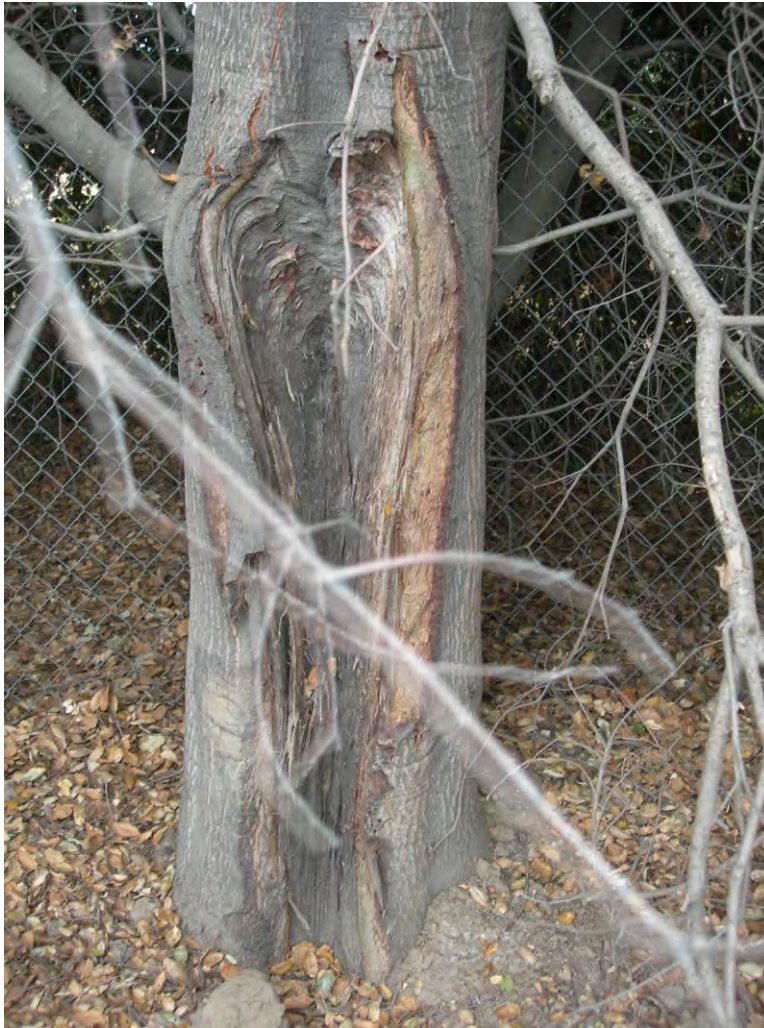
This tree has been significantly damaged by the failure of a co-dominant stem on the east side of the trunk. The resultant exposed wood extends four feet up the trunk from grade and comprises of up to one third of the entire circumference of the trunk at its widest point. This damaged area of exposed wood will decay over time and will predispose this tree to falling in the future.

Tree #16 – 15 inch Coast Live Oak – Recommended for removal:

- The trunk has been irreparably damaged

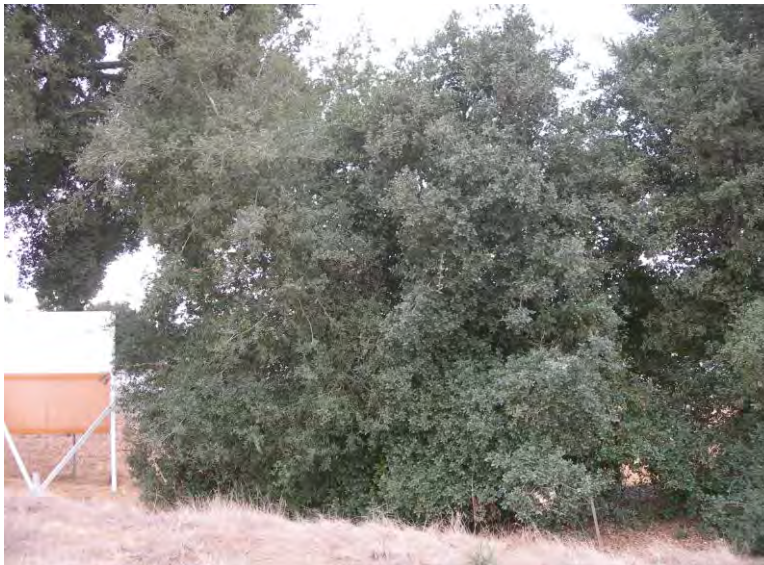
Tree #18 – 12 & 11 inch Coast Live Oak - Recommended for preservation:

- This tree should be pruned to reduce weight on heavy limbs and to raise the canopy

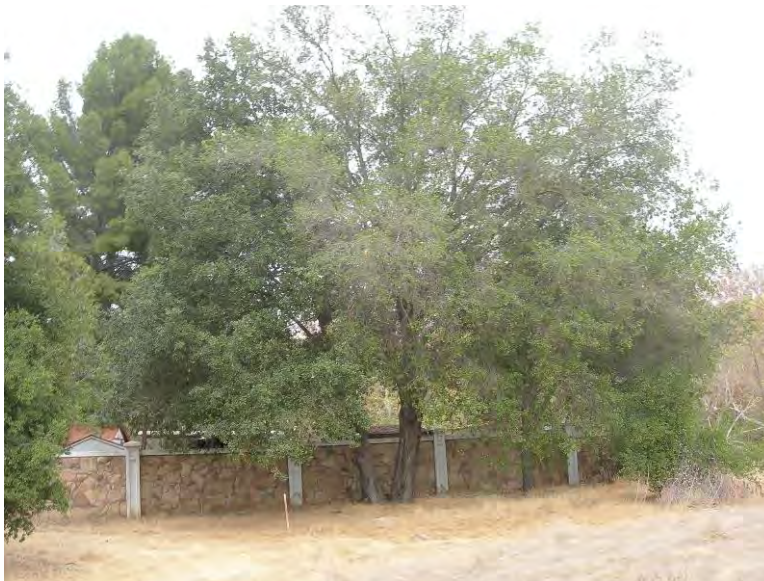
Trees #19, 20 & 21 – Three Coast Live Oaks near the east boundary – Suitable for preservation:

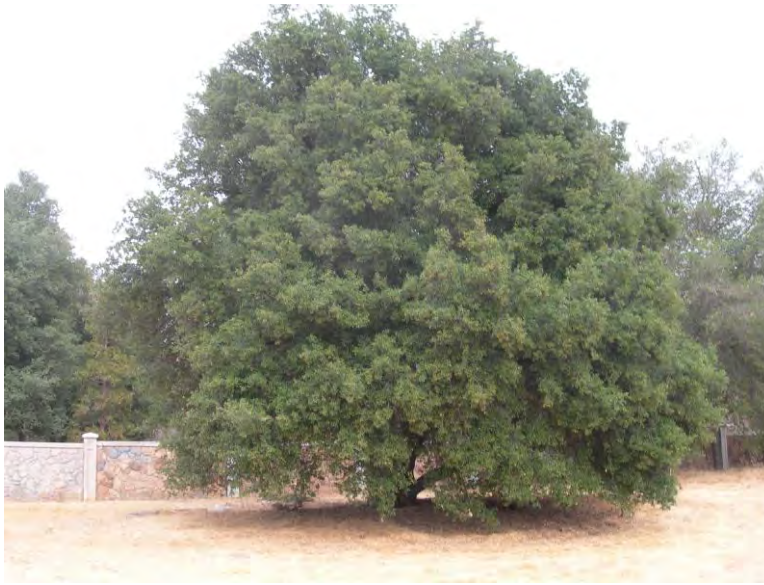
This tree has a relatively poor structure due to having three co-dominant scaffold limbs that emanate from a common trunk. The areas of attachment between these trunks are narrow and exhibit areas of trapped bark (inclusions) which represent structural weaknesses. I recommend the installation of three triangulated support cables to help mitigate this situation. Note that due to the growth pattern of this tree, 5/8 or ½ inch diameter Jay lags will have to be utilized as cable attachment points in this case.

Tree #22 – 17, 17 & 18 inch Coast Live Oak – Suitable for preservation:

- Prune and install cables to improve structure and appearance

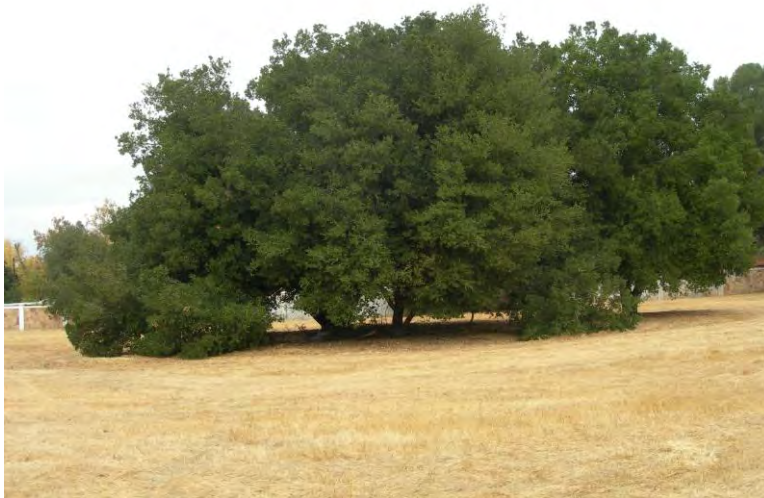
Tree's #23, 24 & 25 – Three large Coast Live Oaks:

- Note that Tree's #23 & 25 are recommended for preservation being the two largest oaks
 - Tree #24 is recommended for removal being a crowded and suppressed specimen

This large tree should also be pruned as recommended for Tree #23. Tree protection zone fencing must be installed at or beyond the canopy drip line before any site work proceeds.

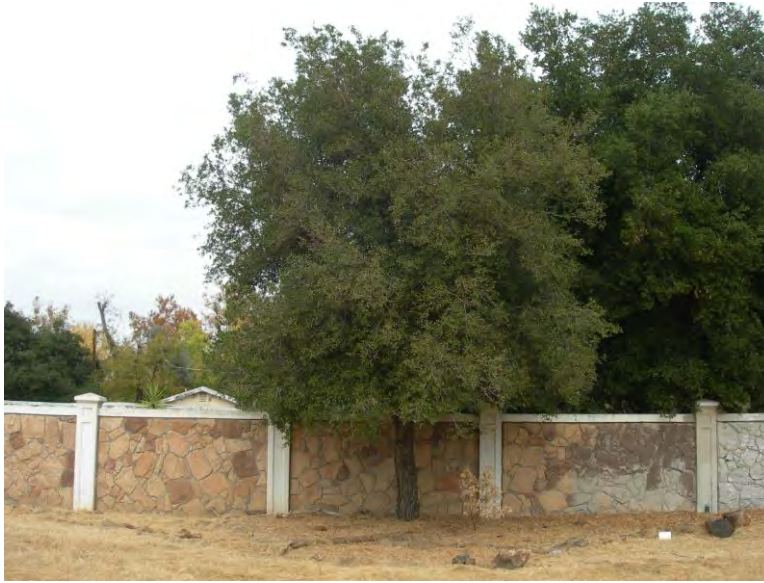
Tree #26 – 15 inch Coast Live Oak – Suitable for preservation:

- Located near the east boundary wall

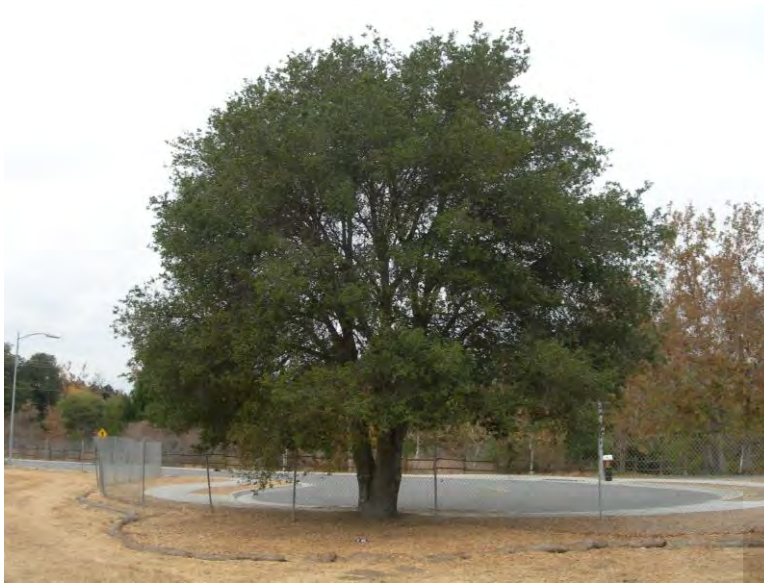
This tree is located in the proposed driveway entrance and exit to the complex at the south end of Silver Creek Valley Place. The tree can be preserved on site if a generous area of native soil and critical root zone can be retained on all sides of the trunk (a minimum area equivalent to the total area of the tree canopy is recommended). I noted on the conceptual plan overlay that the soil area surrounding this tree will be inadequate for its survival. The tree must be re-located if this design cannot be changed.

Tree #27 – 21 & 17 inch Coast Live Oak – Recommended for relocation:

- Located in the area of the proposed entrance to the center

Supplemental irrigation is recommended for Tree #4 and Tree #27 (after relocation). Irrigation must be applied at a rate of 10 gallons per inch of trunk diameter at 54 inches above grade every three weeks from April through October (or until the first substantial rain). I recommend the utilization of irrigation

tubing such as the Netafim product to deliver water to their root zones. This tubing must be laid out in circles under the outer half of the tree canopies to avoid excessive moisture in close proximity to their root collars.
